Up Close: Metal Roofing and Gutters

Ridgewalker News

LEVINE & COMPANY, INC.
ROOF CONSULTING AND ARCHITECTURAL CONSERVATION

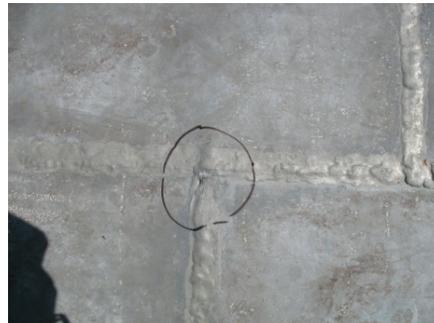
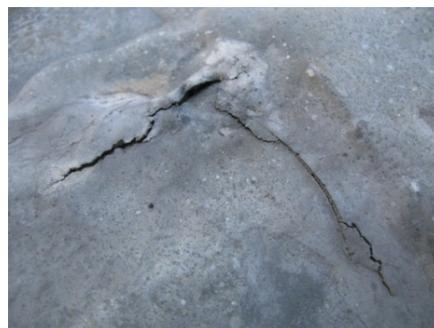
The two photos above show a cracked seam viewed from three or four feet up (top) and when viewed close-up. The close-up view shows that not only is the solder cracked, but the metal has fatigued and cracked, as well.

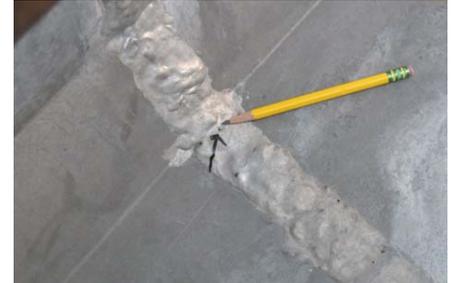
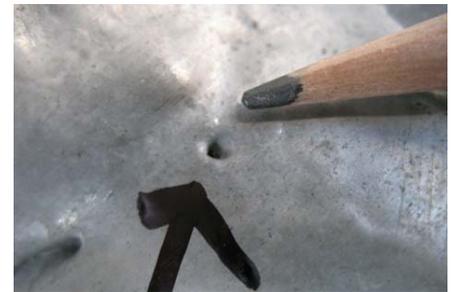
While surface tension might prevent this open rivet from leaking during a light rain, put a head of water in the gutter and this hole will allow water to pass.

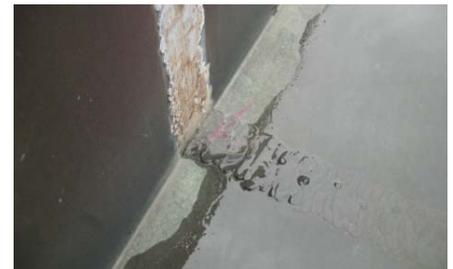
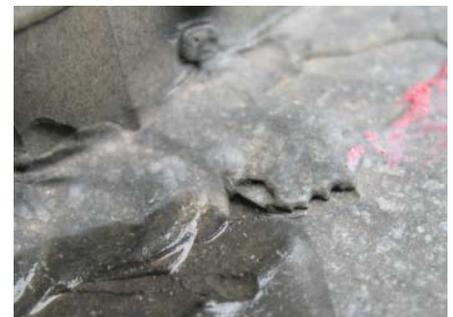
Although the holiday in this lapped, riveted, and soldered seam is only about 1/16" wide, it offers a direct path for significant water entry, especially if the gutter outlet tube should clog and a head of water form.

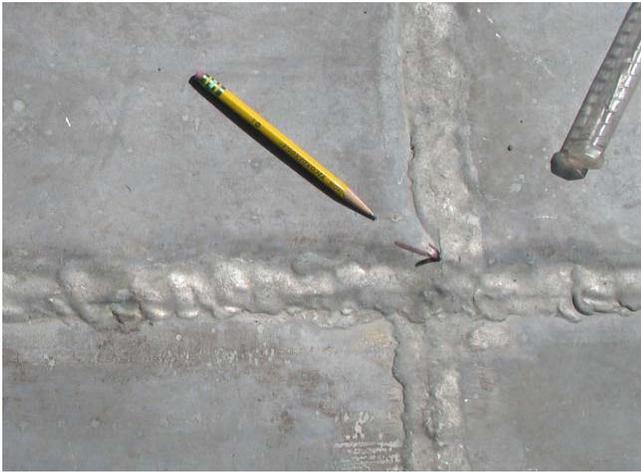
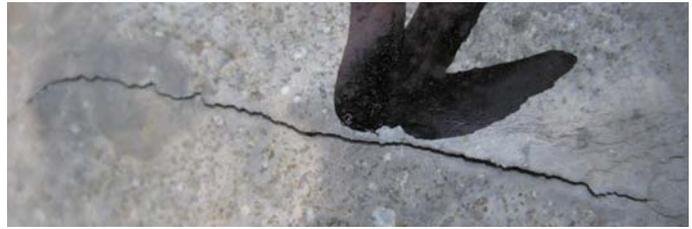
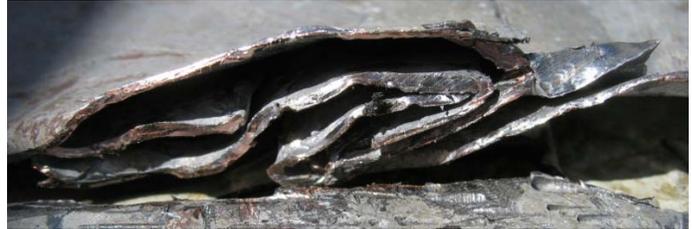
Contrary to industry standards, the locked and soldered seams in this flat seam, lead coated copper roof were soldered using a torch (rather than an iron). Many of the seams cracked. When cut open, it was found that the solder was not sweat through at all. All of the layers (four typically; six in the photo due to the presence of a cleat) should be completely filled with solder.
