Up Close: Slate Headlap and Offset

Ridgewalker News

LEVINE & COMPANY, INC.

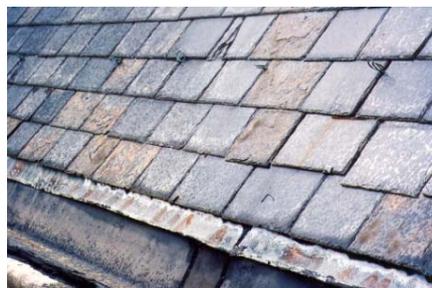
The roof below leaked for years after replacement of its built-in gutter liner with a new EPDM (never a good idea) liner. Everybody suspected the EPDM liner. Nobody bothered to check the slate above, which had been removed, salvaged, and reinstalled to permit the gutter replacement work.

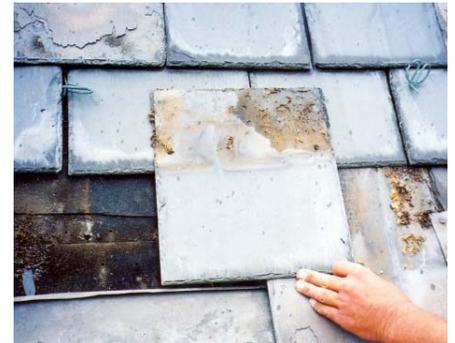
A test opening revealed that slate in the second course had been trimmed, or replaced with shorter, reclaimed replacements, the result of which was no headlap (see photo below)! Rainwater was free to enter the roof system at each and every side joint between slates in the course above.

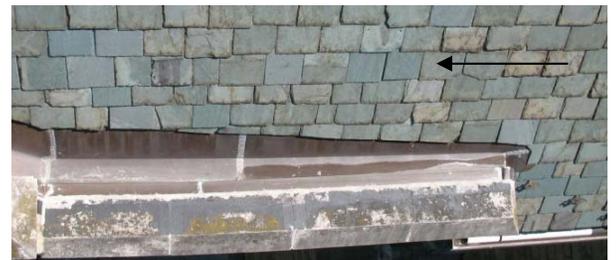
That's no optical illusion; the exposures of the slates in the fourth course above the copper gusset in the photo below taper from left to right. They should not taper. The result is minimal to no headlap at the far left end.

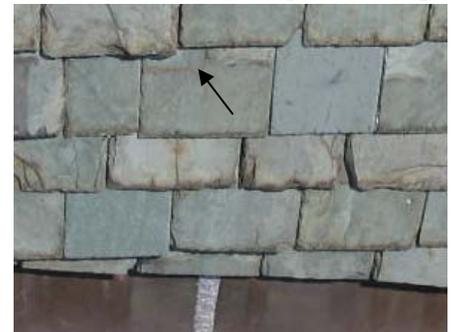
In addition to enlarged exposure, look for butt-line ghost-lines (arrow below) that are too low in reinstalled slate, as these can indicate inadequate headlap.

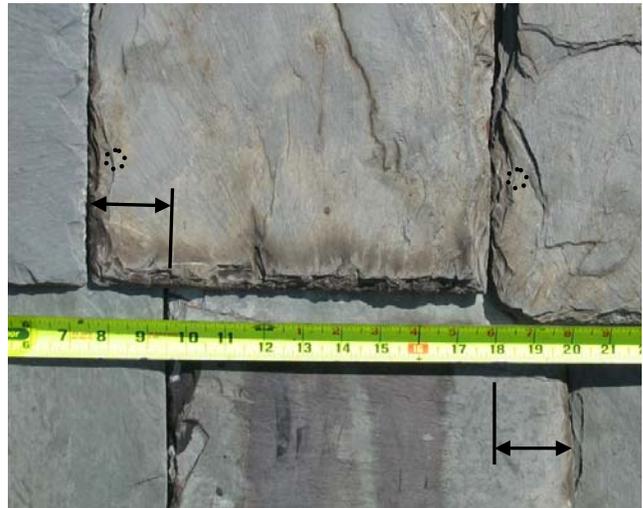
These slates were reinstalled with a 2" offset. This places the nail holes in the slates below too close to the bond lines (joint between slate shingles). The nail holes, thus, become susceptible to water infiltration during heavy or wind-blown rains.
