Drainage, Thermal Movement, and a Double Outlet Tube

ST. MARY'S EPISCOPAL CHURCH ROOF REHABILITATION

Ridgewalker News

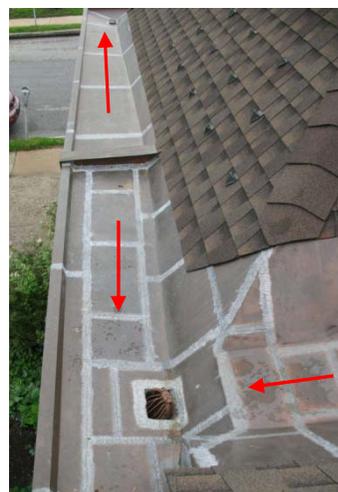
Figure 1: Built-in gutter and gusset intersection

Levine & Company encountered such a condition at St. Mary's Episcopal Church in Ardmore, Pennsylvania, where a large gusset intersects a wide built-in gutter with an outlet tube located at the point of intersection (see figure 1). The solution involved five key details. First, the new gutter liner was constructed from relatively small flat seam copper pans which are better able to accommodate thermal movement at right angle intersections than 8- or 10-foot long copper sheets. A new, raised expansion joint was installed closer to

the outlet tube to isolate the flat seam gutter pans from the longitudinal pans used elsewhere in the gutter. The north end of the gutter was re-sloped away from the point of intersection (the high point used to be located at the far corner of the building), significantly reducing the amount of water flowing toward the intersection. Ice dam protection membrane was installed below the copper pans at the point of intersection to catch water should it penetrate the gutter or gusset. The final touch was a double outlet tube; a back-up plan, if you will, acknowledging that although we did our best to accommodate stress on the soldered seams, if a seam should crack in the future, no water will enter the building.

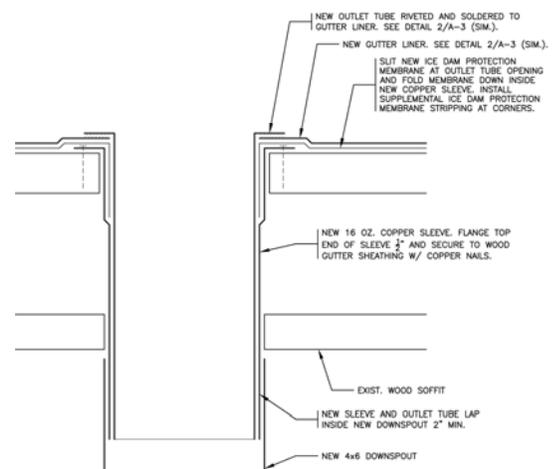
Figure 2: Detail of double outlet tube

The double outlet tube we designed is a tube within a tube (see figure 2). The inner tube receives all the water from the flat seam gutter and gusset, provided, of course, that the soldered seams remain intact (we have every confidence that they will). The ice dam protection membrane below the gutter liner laps inside the mouth of the outer tube, or "sleeve," thus creating a secondary layer of protection. Any water which might penetrate the flat seam copper flows along the ice dam protection membrane, through the sleeve, and ultimately into the downspout (exactly where it should be).
