Frost Patterns – Survey Aid

Ridgewalker News

LEVINE & COMPANY, INC.
ROOF CONSULTING AND ARCHITECTURAL CONSERVATION

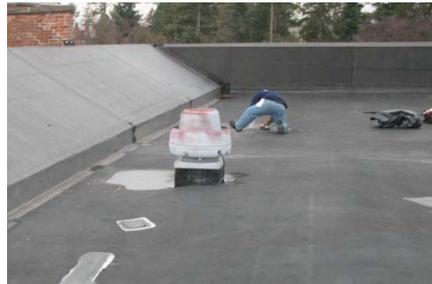
▲ Overall view of the roof on a typical afternoon.

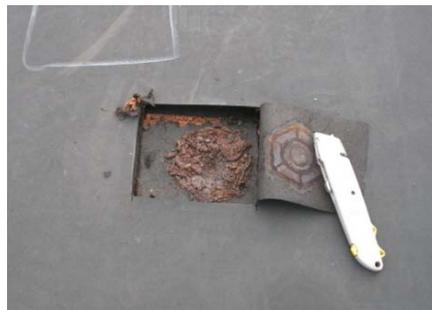
Test openings the previous afternoon at a roof located in upstate New York had revealed warped insulation panels, condensation on the underside of the insulation panels, corroded insulation fasteners, and air movement at the concrete roof deck/insulated metal wall panel interface.

▲ Corroded fastener plate

To help prevent these problems from recurring, Levine & Company specified several remedies in the bid documents for roof replacement, including drying out of the concrete roof decks, installation of a continuous air/vapor retarder membrane at roof/wall interfaces and parapet walls, and installation of two layers of polyiso insulation plus a cover board, with the first layer of insulation mechanically fastened and the second layer of insulation and cover board adhered using spray foam adhesive. In addition, joints between the layers of insulation and cover board were staggered to further mitigate air movement and heat loss.

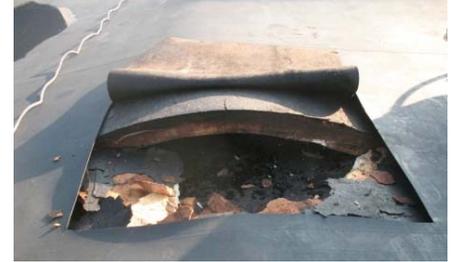
▲ Single layer of polyisocyanurate insulation. The insulation warped as a result of condensation on its underside and fastener corrosion. Source of the moisture – interior air.

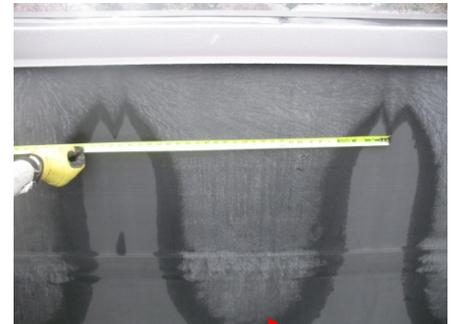
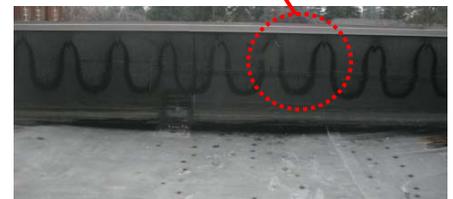
As you might imagine, it is hard to photograph the movement of air. Frost brought these, and other, conditions to life in a dramatic way, and helped illustrate the magnitude of the problem.

▲ Frost patterns on the EPDM clad parapet walls formed a perfect sine wave. The distance between the peaks of the non-frosted areas matched the width of the insulated metal wall panels exactly, confirming our earlier observation of air movement from the interior into the roof system, but also vividly showing the degree of heat loss through the joints between panels.

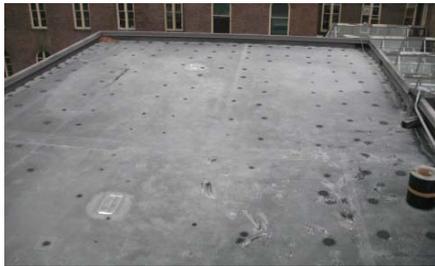
◀ The dark round circles in this photo indicated the insulation’s fastener pattern. The fastener plates are frost-free due to thermal bridging. It is estimated that thermal bridging of fasteners reduces the R-value of insulation by 8 to 10 percent.
