Pennsylvania Hard-Vein Slate

Ridgewalker News

LEVINE & COMPANY, INC.
ROOF CONSULTING AND ARCHITECTURAL CONSERVATION
P.O. Box 628
ARDMORE, PA 19003
+

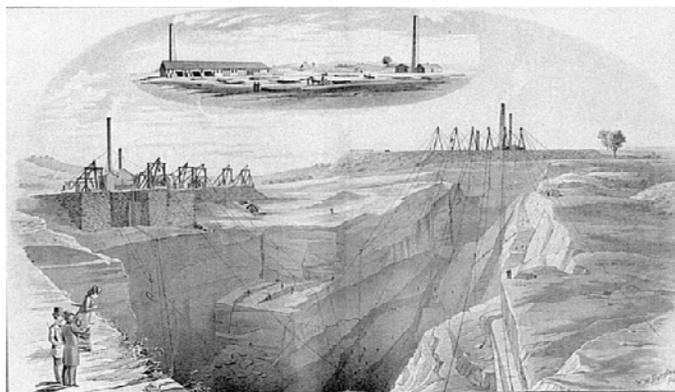
Data accompanying the quaint, c.1875 print shown above indicates the large extent of the quarry: 700 feet long, 300 feet wide, and 225 feet deep.

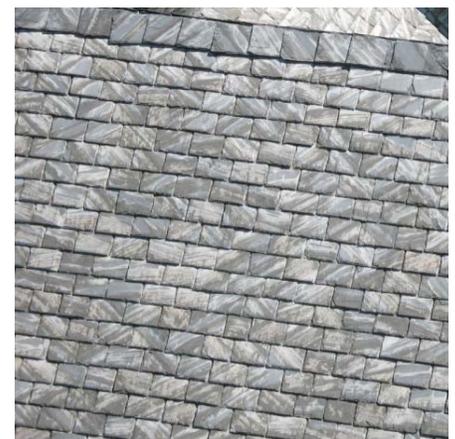
Pennsylvania Hard-Vein slate is blue-black in color when freshly quarried. Its cleavage surface, or face, is marked by closely spaced, light and dark colored ribbons that give the slate a streaked appearance. Today, this can best be seen on vertical walls, where the slate is somewhat protected from the weather (photo at top of next column).

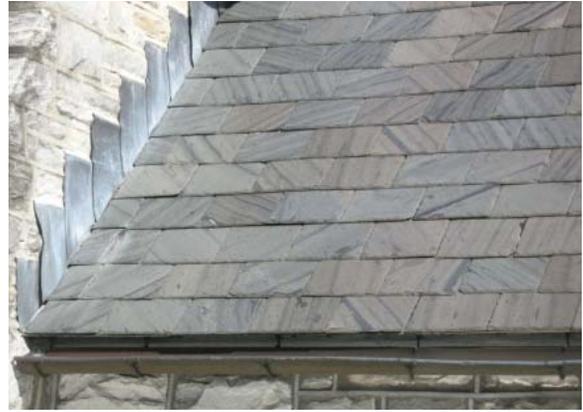
After some years of exposure, hard-vein slate used for roofing purposes takes on a more pronounced streaked appearance as the ribbons become more prominent and can be seen to be oriented at various, random angles across the face of the slate (see photo at bottom of column). In some environments, weathered slates can take on a light orange hue. Wall cladding slates sometimes turn a matte green color.

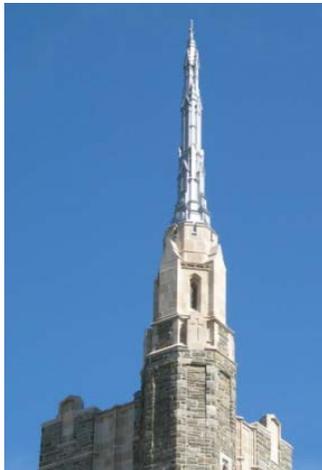
Bryn Mawr Presbyterian Church: The new, 30-foot tall, lead coated copper spire previously reported as being fabricated by Campbellsville Industries, Inc. (Ridgewalker News, Winter 2014) was installed in late March without a hitch, much to the delight of several dozen spectators. The tower was lifted via crane, leveled, and bolted in position. The spire's internal lightning protection cable was then connected to a previously installed conductor cable that runs to a ground rod at grade.

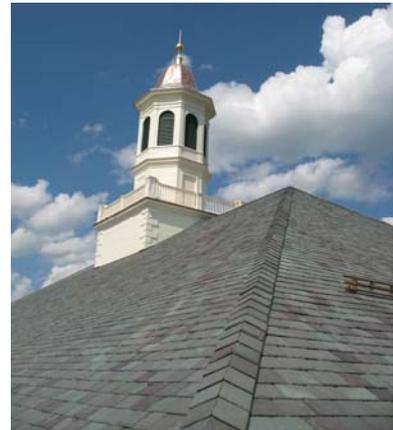
All Campus Dining Center (ACDC), Vassar College: Phase 1 of the ACDC roof replacement project received a Gold Circle Award for Outstanding Workmanship – Steep Slope from the National Roofing Contractors Association. The award went to Hayden Building Maintenance Corp., Nyack, New York, who, working to L&Co.'s specifications and detailed design drawings, did an outstanding job replacing the building's mottled purple and green slate roof, copper built-in gutters, flat seam copper roofing, and gold leafing the existing copper finial.
