Red Lead Oxide Staining – An Environmental Phenomenon

Ridgewalker News

LEVINE & COMPANY, INC.

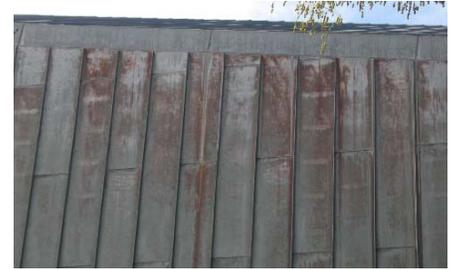
For most of the twentieth century, there were enough pollutants in the atmosphere (mainly sulphur dioxides stemming from the burning of fossil fuels) for high-lead alloy metals (e.g., TCS and lead coated copper) to react with the pollutants to form a dark gray, lead sulphate patina (chemically, likely $PbSO_4$). In the absence of these pollutants, a rusty, reddish-brown colored staining can form on the surface of TCS (photo at top of next column). Lead in the lead-tin coating of the TCS oxidizes to form red lead oxide, chemically PbO or, likely more frequently, Pb_3O_4 . PbO is reddish-yellow in color. Pb_3O_4 is orange-red in color.²

pollution. With stricter environmental regulations in the later part of the twentieth century, there are fewer sulphates in the atmosphere and the problem of red oxide staining of lead-bearing metals is becoming more widespread. The formation of Pb_3O_4 , red lead, is favored in cleaner, less-polluted air.

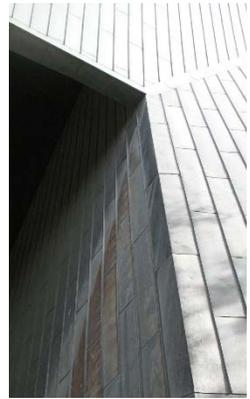
Fortunately, the consensus seems to be that red oxide staining is a surface phenomenon; a natural patina, with no significant accelerated or detrimental corrosion of the stainless steel substrate taking place. In other words, the staining is primarily an aesthetic issue, not a performance issue in most cases. The exception would be “micro-climates” where water washing is the primary feature. Water washing over a surface is, by its nature an erosive process, however slight and however slow. Coating loss will occur. It is, however, unlikely to impact the integrity/watertightness of the TCS panels as the stainless steel base metal is, itself, very resistant to atmospheric corrosion and erosion.

Removal of red oxide staining is difficult and expensive. Moreover, if the underlying factors contributing to the staining are not addressed (also difficult), the staining will recur. In most instances, therefore, allowing the staining to remain and permitting the TCS panels to patina naturally is recommended.
