Never Too Steep; Sometimes Not Steep Enough

Ridgewalker News

LEVINE & COMPANY, INC.
ROOF CONSULTING AND ARCHITECTURAL CONSERVATION

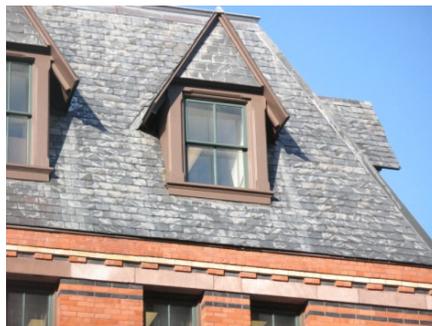
Pennsylvania Hard-Vein (Chapman) slate (see *Ridgewalker News* Vol.9, No.2) has an expected service life of about 100 years. This assumes a typical roof slope of between 8:12 (34°) and 14:12 (49°). Put the same slate on a Mansard roof with a slope of 25:12 (65°), like that the one pictured below (installed c.1895), and the service life shoots up to 120 years and still counting.

Steepness counts when it comes to the longevity of slate roofing. All other things being equal, the steeper the roof slope, the longer the slate shingles will last.¹

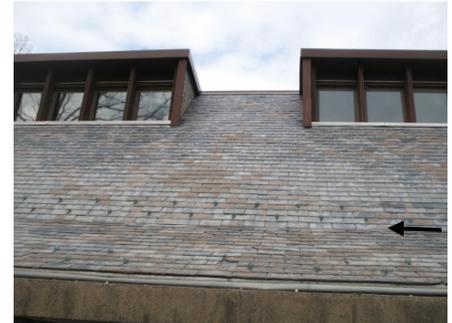
The Pennsylvania Black slate pictured on the roof at the top of the next column was installed c.1968. The roof contains a distinct pitch break, demarcated by the arrow. Slate on the upper section of the roof, where the roof slope is 13:12 (47°), is in decidedly better condition than that on the lower section of the roof where the slope is just 6:12 (27°).

Slope matters for several reasons: Snow and ice loads tend to be greater on lower sloped roofs. The added weight can cause slates to crack. Snow and ice also tends to push and jostle the slates, further increasing the chance of cracking and breakage over time. Perhaps more importantly, the lower the roof slope, the longer it takes for rainwater to drain off completely (i.e., the longer the slates stay wet) and the wider the angle of creep (the tendency of rainwater which enters the keyways between slates to spread fanwise between the overlapping slates). Lastly, the likelihood of foot traffic on lower sloped roofs is greater and with greater foot traffic comes the inevitability of greater numbers of broken slates.

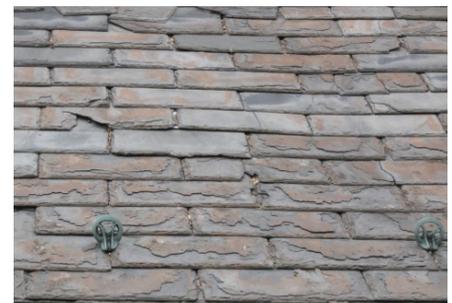
The final photo illustrates the condition of the slate on the 6:12-slope section of the roof. It is severely delaminated and contains many cracked and broken slates. It should be replaced now (or, perhaps 5 years ago), whereas the slate on

the upper section of roof has a remaining service life of approximately 10 years. The slate on the 6:12 slope suffered a reduction in service life of approximately 20%.

The International Building Code (and tradition) allows slate shingles to be installed on roof slopes as low as 4:12 (18°), provided that a 4" headlap is used. While permitted, it is often not recommended. Slate laid on slopes ranging from 4:12 to 6:12 is not very visible from grade, relies more heavily on the roof underlayment system (which necessarily must be punctured by fasteners), and will not obtain the full expected service life of the slate. Other materials, such as standing seam or batten seam copper, for example, often are a better choice.
