Do it Right, Do it Once

Little Things Can Make A Big Difference

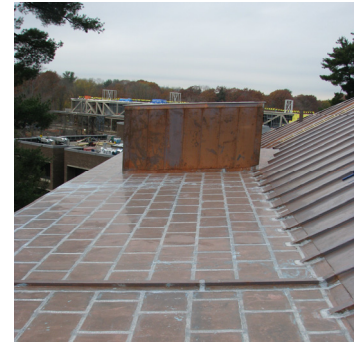
Flat seam copper roof comprised of pans no larger than 18"x24". Note also the expansion batten.

In flat seam metal roofs, the pans are cleated to the roof deck and locked and soldered together, which prohibits movement at the seams. In properly detailed flat seam roofs, the individual pans can accommodate a certain amount of thermal movement via "oil canning," whereby the surface of the pan flexes upward slightly when the metal heats up (i.e., when it expands) and flattens when the metal cools (i.e., when it contracts). Large pans can suffer severe distortions as a result of oil canning or may not be able to oil can enough, depending on their size. With oversized pans, the strain produced by thermal movement can cause the soldered seams to crack or fatigue cracks to form in the metal, thereby undermining the watertightness of the roof system. For this reason, industry standards, such as Revere Copper Product's *Copper and Common Sense*, limit the size of flat seam roof pans to a maximum of 18"x24" (prior to hemming the edges). Based on the formula above, a pan of this size will expand/contract less than 1/16" per year in each direction.

Correct pan size is not the only critical factor for a long-lasting flat seam roof. Metal gauge selection, seam dimensions, fully sweating the soldered seams, and properly detailed expansion joints (if the roof is larger than 30 feet in any direction) are also essential to the longevity of flat seam metal roofs, but these are topics for other newsletters!
